Team Semi Driver Dies after Rig is Struck by Impaired Driver

Incident Number: 07KY091

Kentucky Fatality Assessment and Control Evaluation (FACE) Program
Incident Number: 07KY091
Release Date: February 17, 2010
Subject: Team Semi Driver Dies after Rig is Struck by Impaired Driver

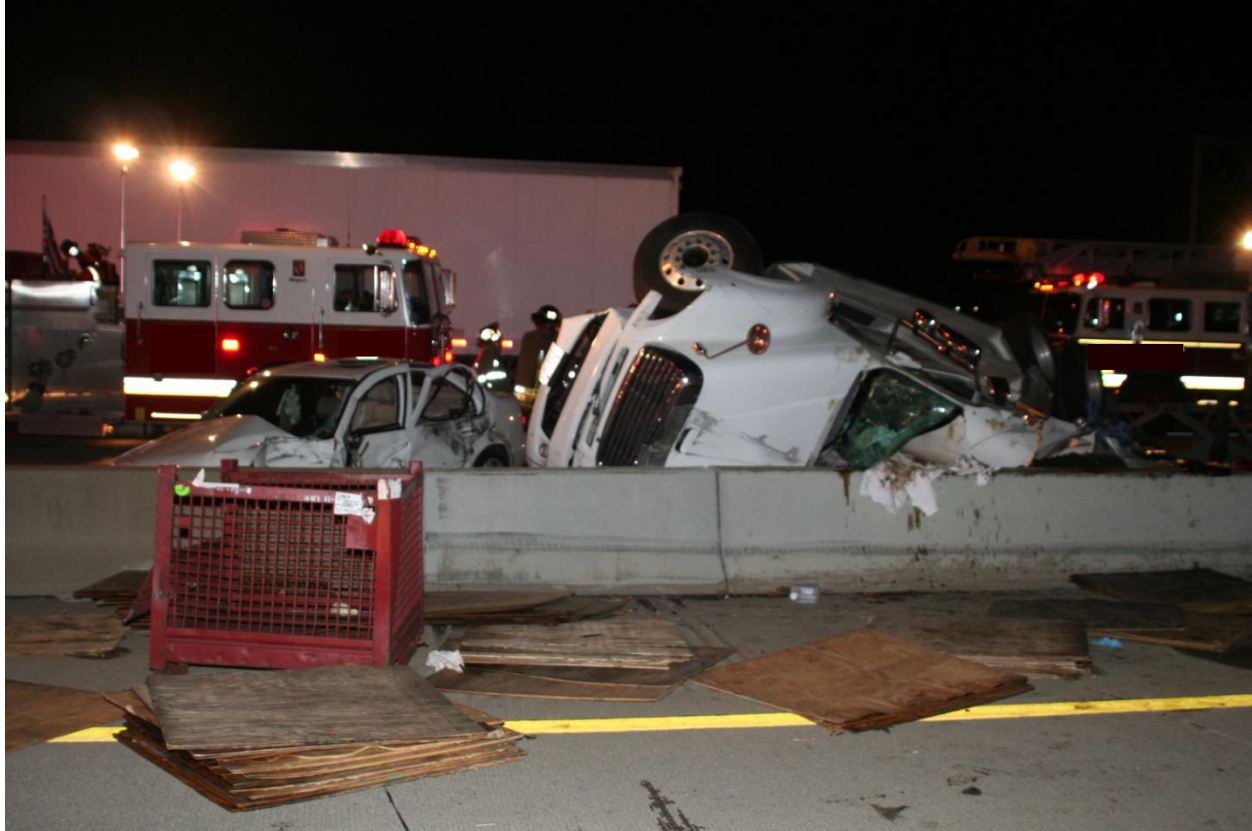
Photograph of semi and car involved in fatal crash. Photograph courtesy of law enforcement.
